US Army Corps
of Engineers
Construction Engineering
Research Laboratory

TECHNICAL REPORT M-86/14
July 1986

Field Test Results of Aluminum Standing-Seam Roofing

by
Myer J. Rosenfield

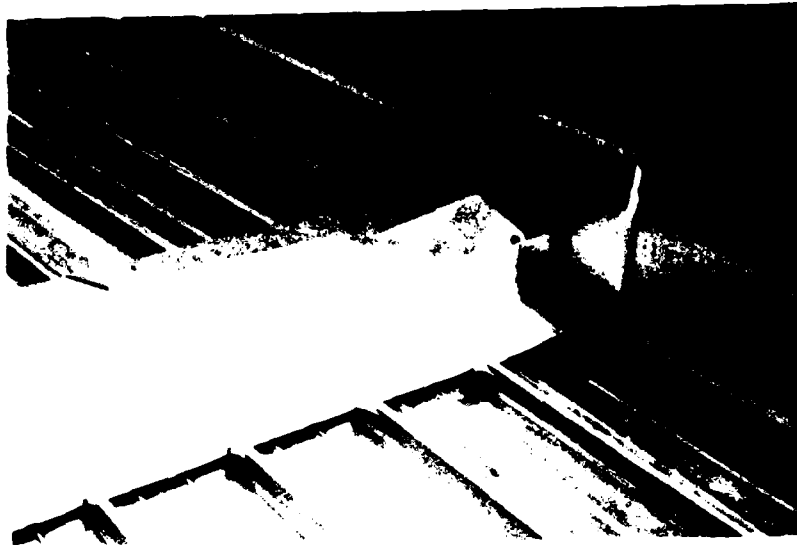
inadvertently stepped on, which probably caused the damage shown in Figure 17, it may not be possible to straighten the cap without first removing it. It is unlikely that the damage was caused by expansion. An expansion joint is visible in Figure 17 and its design is such that it should act as a slip joint between sections.

Figure 17. Damage to ridge cap (July 1983).

The ridge caps will be the easiest components of the roofing system to remove, repair, and replace. At the firewall ends, the ridge caps should be anchored to the walls by aluminum or stainless steel clip angles. The counterflashing could then incorporate a flange to cover the cap. Fasteners holding the ridge cap flanges to the panel closures should be removed and the holes sealed with closures similar to tinker's dams. Clip angles should be attached to the panel closures, and the ridge cap fastened to these clips through slotted holes. This recommendation is illustrated in Figure 34. Ridge cap expansion joints should be checked to determine if they are free to slide, and comply with the manufacturer's recommendation (Figure 19).

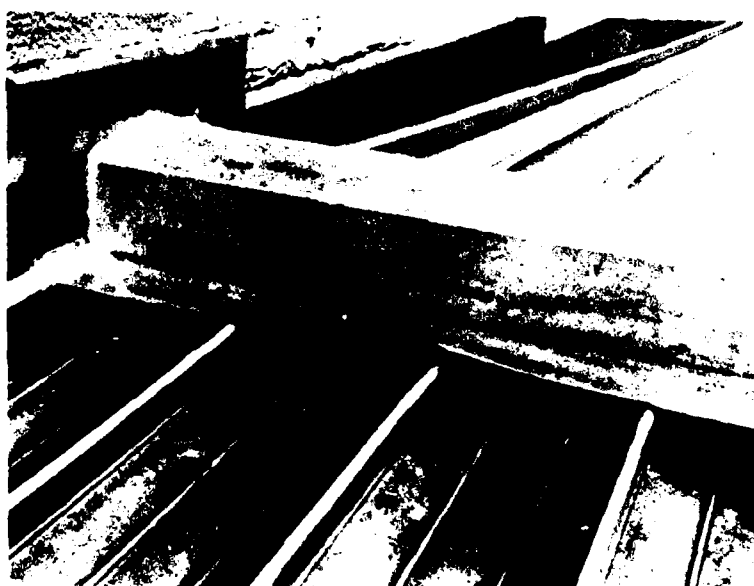
Figure 20. Buckled flange of ridge cap (July 1984).

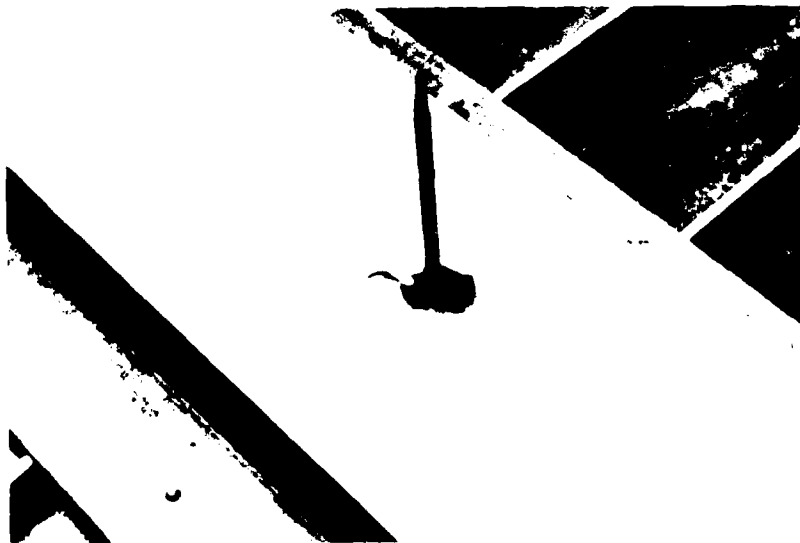
The original lightning protection system was left on the buildings when the aluminum roofing was installed. No provision for this could be found in the specifications and no details were on the drawings.

Figure 30. Lightning rod installation (January 1984).

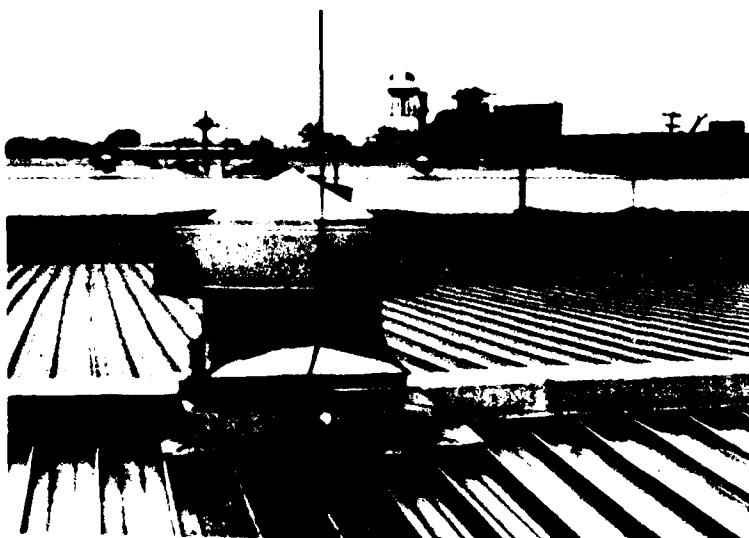
Figure 32. Lightning rod on ventilator (January 1984).

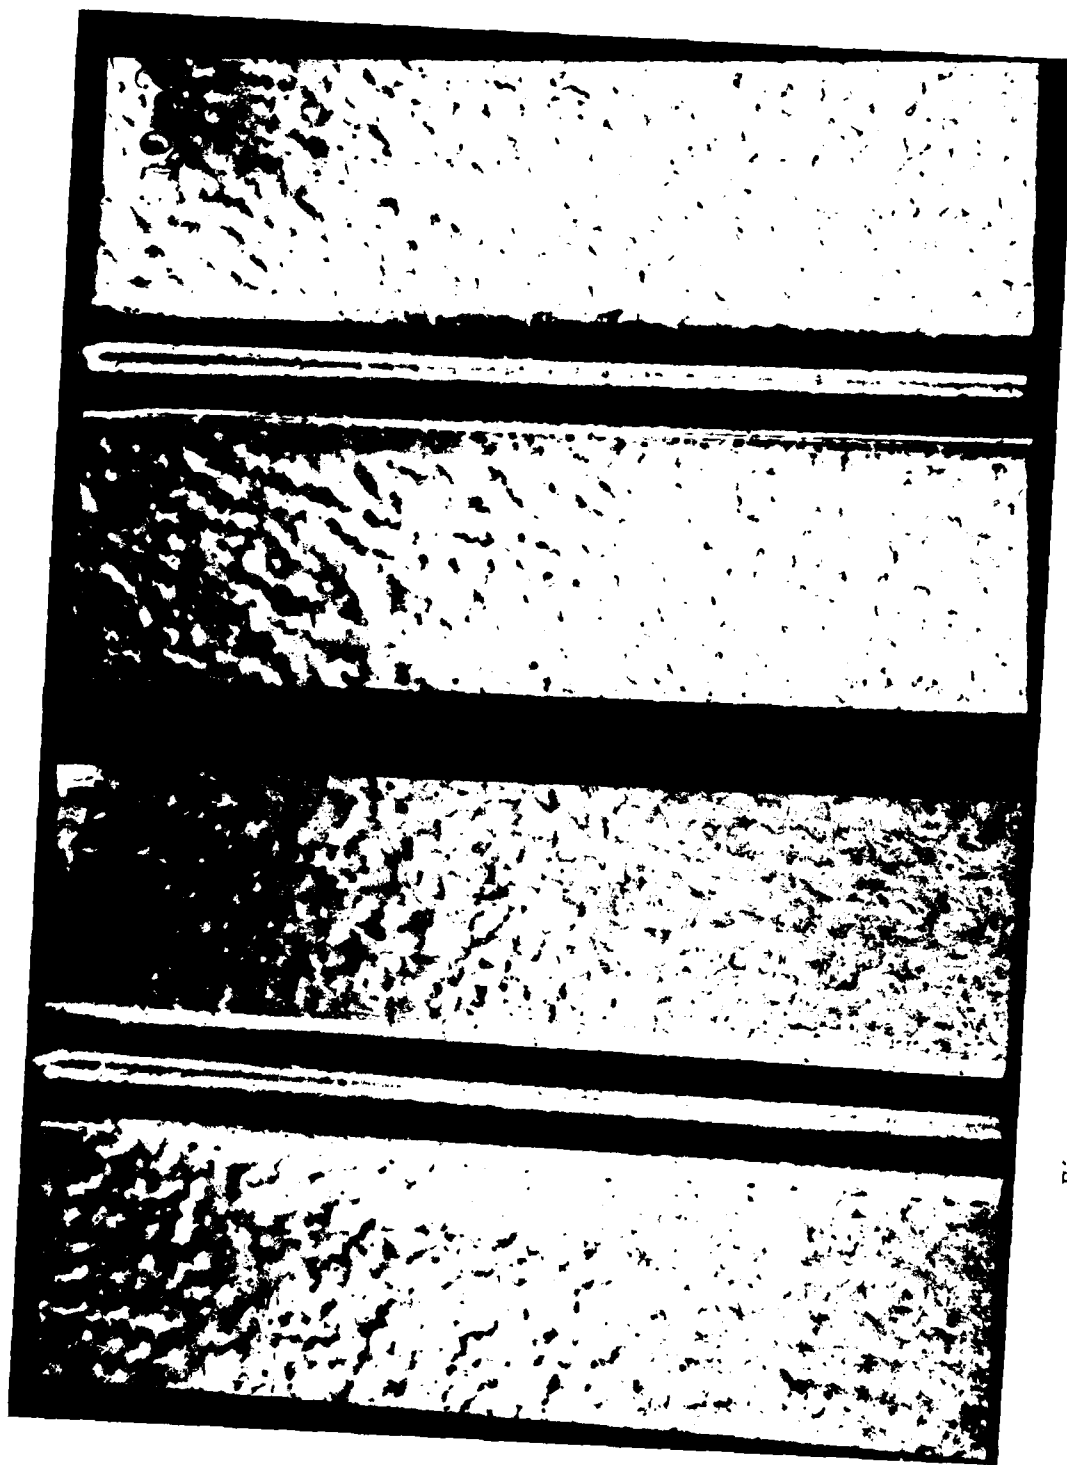
ASTM Standards G1-81 [4] and G48-76 [5] were considered in examining and determining the extent of corrosion. It can be seen from the photograph (figure A3) of a typical exposed and control sample, that the exposed sample on the left has less gloss and greater surface roughness than the control sample on the right. Also, it can be seen that the surface of the exposed sample contains many small dark spots. It is thought that these dark spots

Figure A3. Exposed (left) and control (right) specimens.
